# **Failure Analysis of Failed PMTs**

## **Progress report**

7-26-04

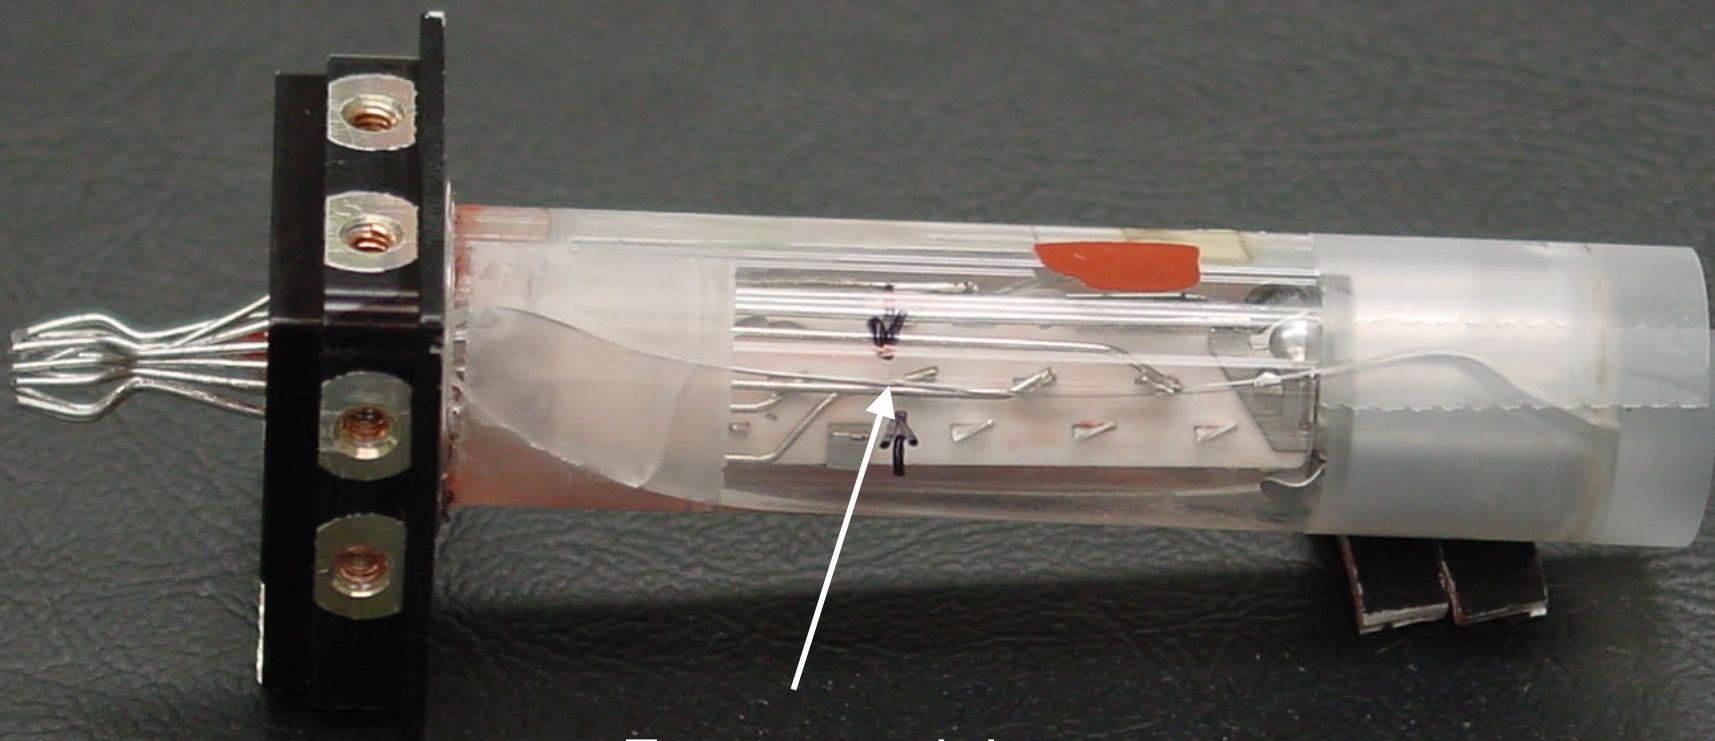
| PMT | Thermal history | Fracture origin<br>(all on outside) |
|---|---|---|
| AA0379 | +40°C to -30°C/1 cycles | 33 mm @ 9 |

Fracture origin

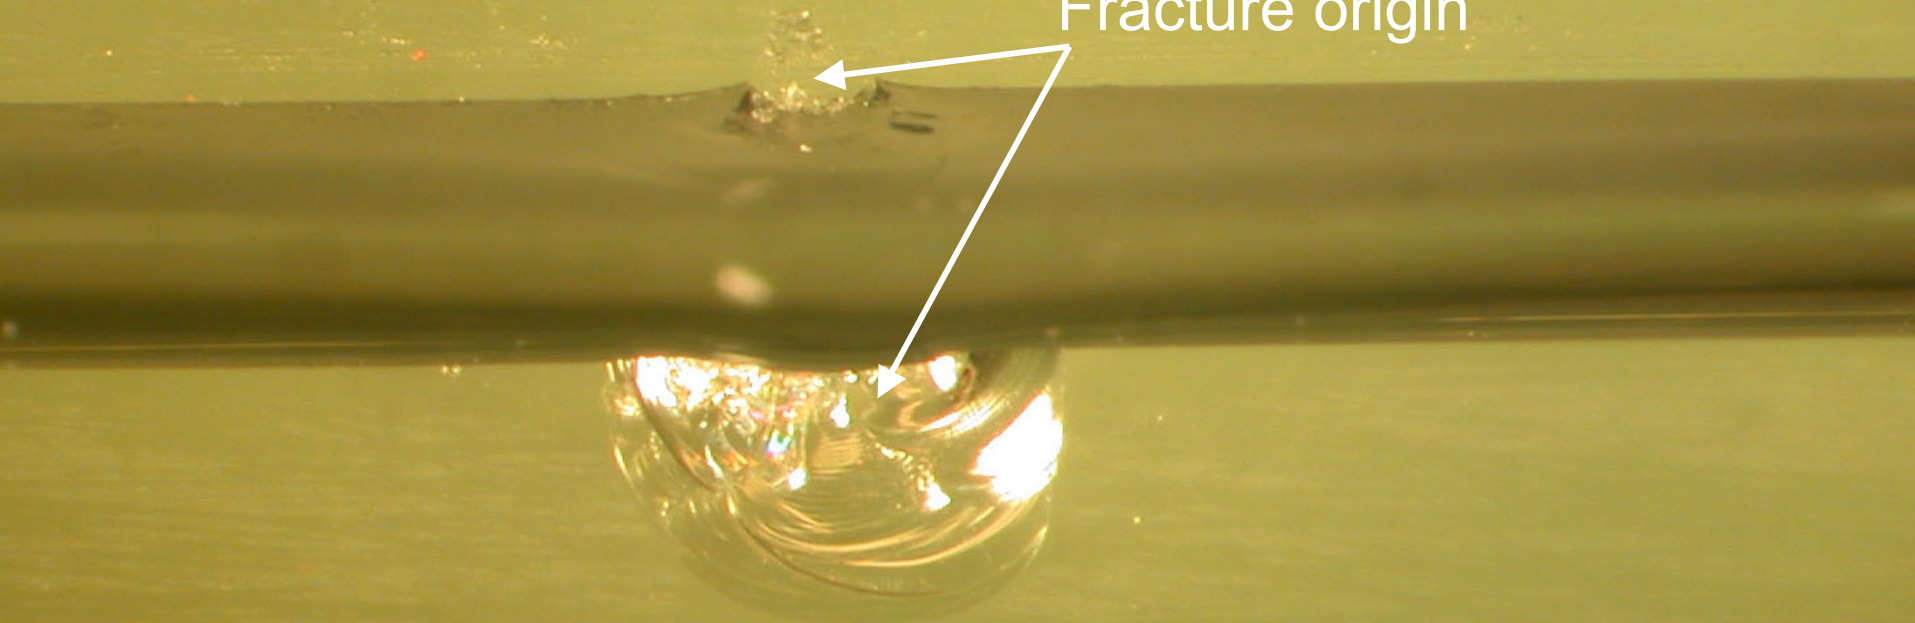
Outside surface of PMT AA0379

Fracture origin

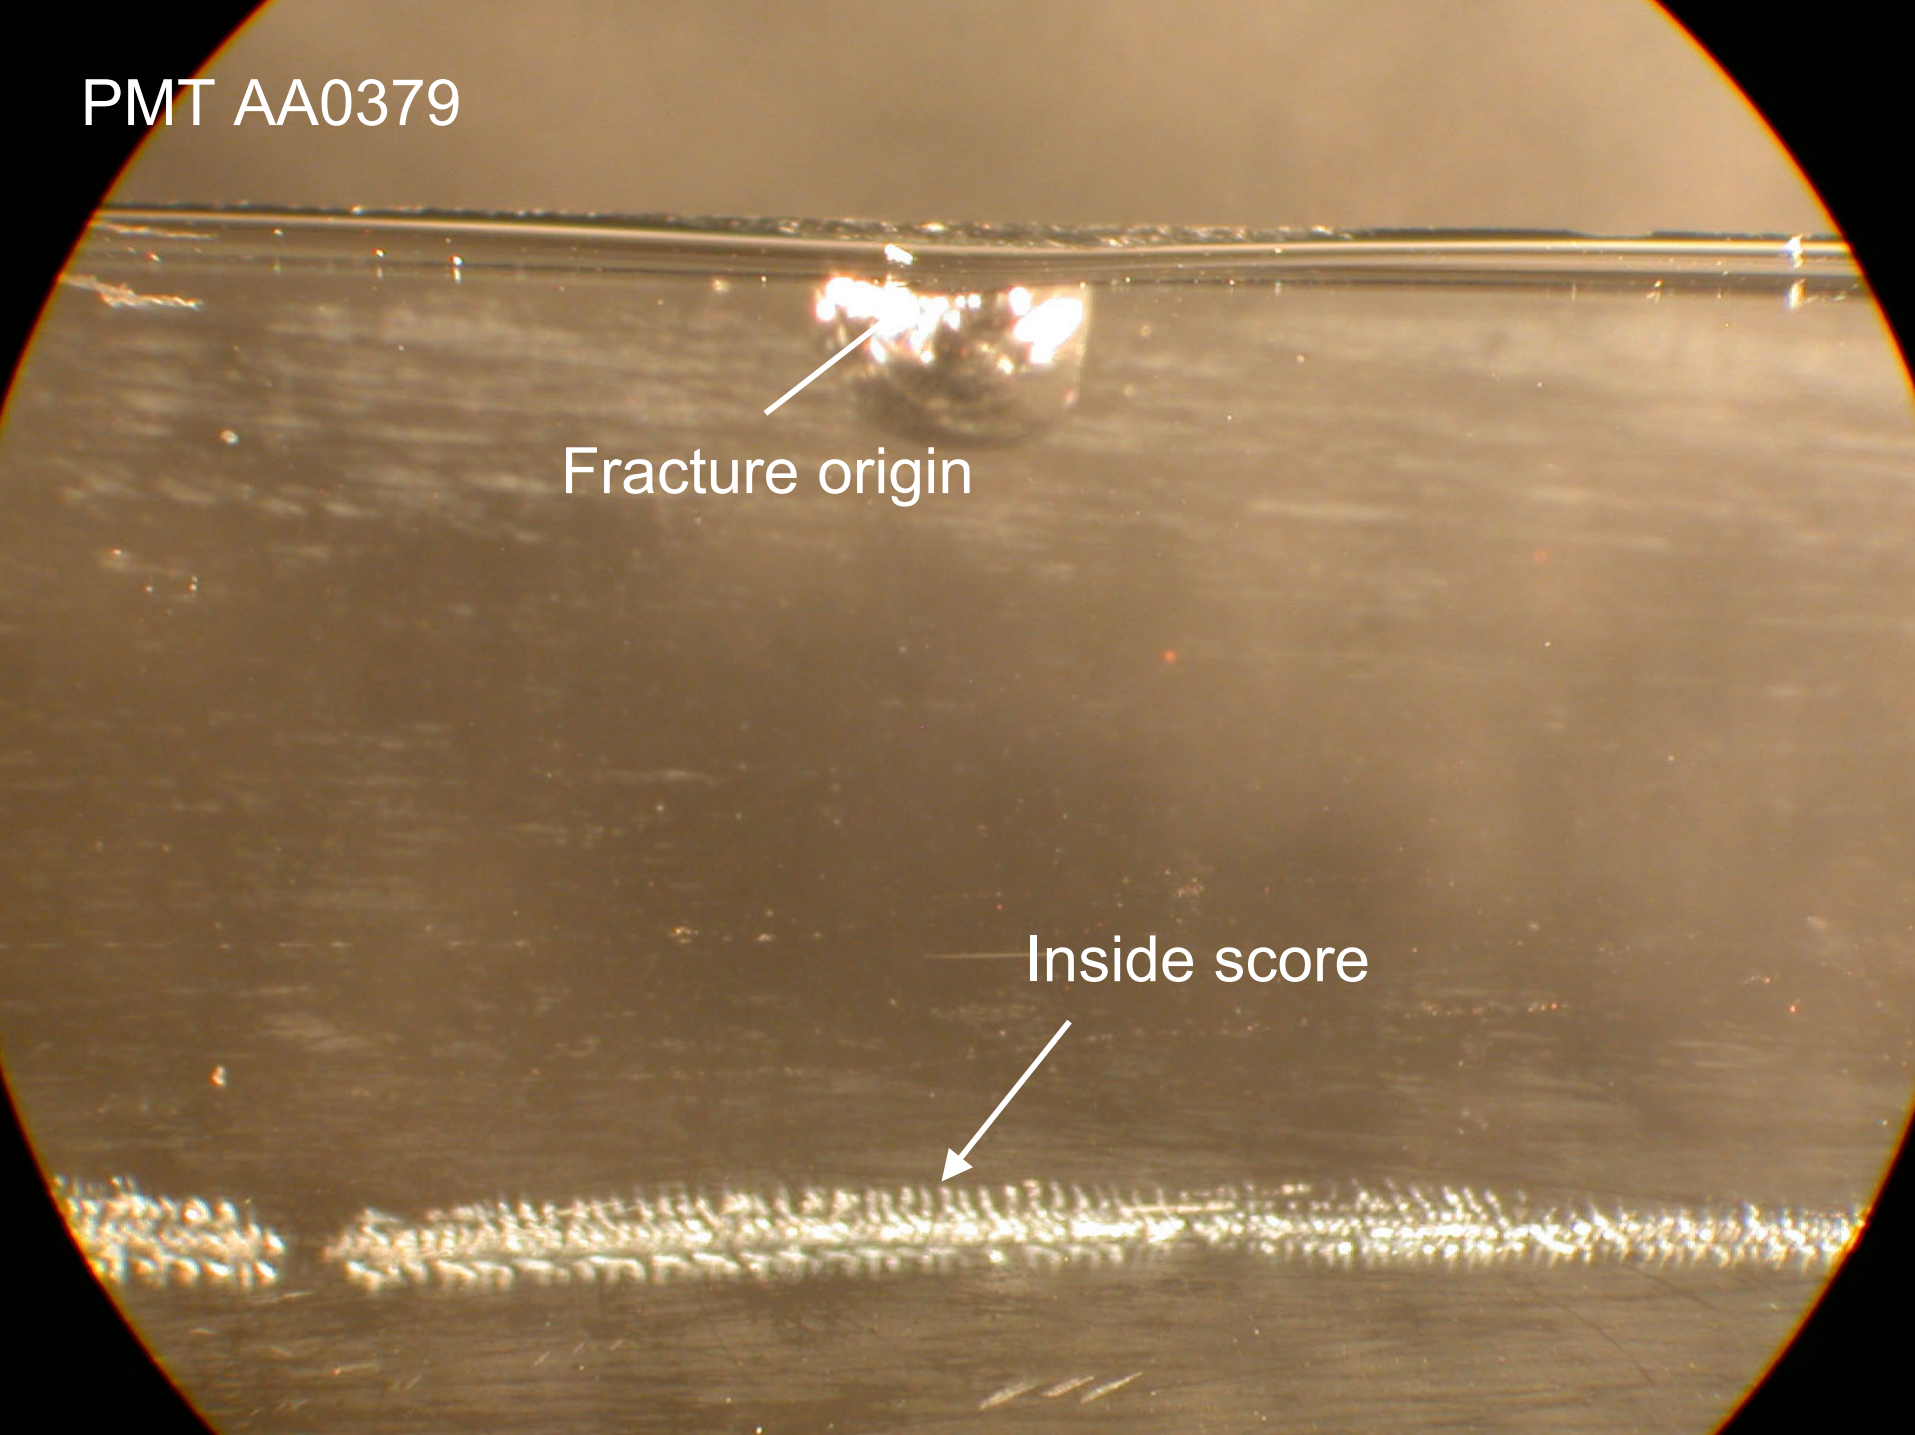
PMT AA0379

Fracture origin

Inside score

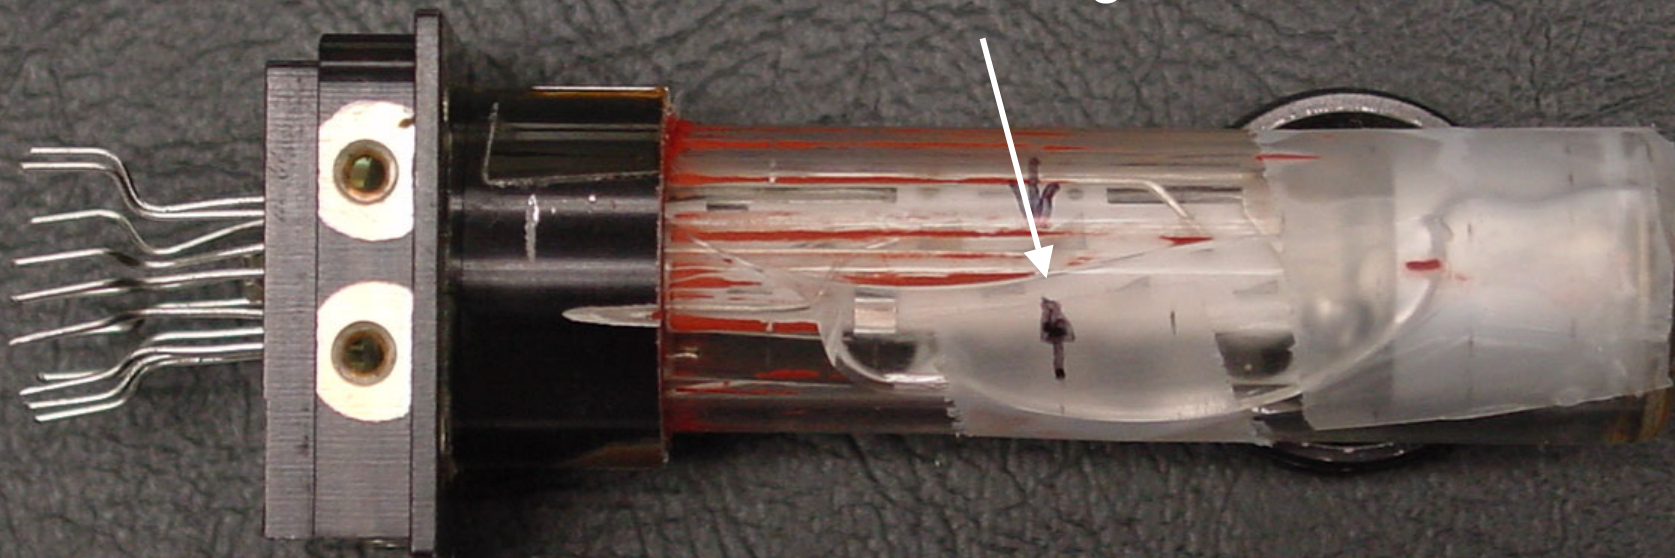
| PMT | Thermal history | Fracture origin<br>(all on outside) |
|---|---|---|
| AA0365 | +40°C to -15°C/1 cycles | 28 mm @ 8 |

Fracture origin

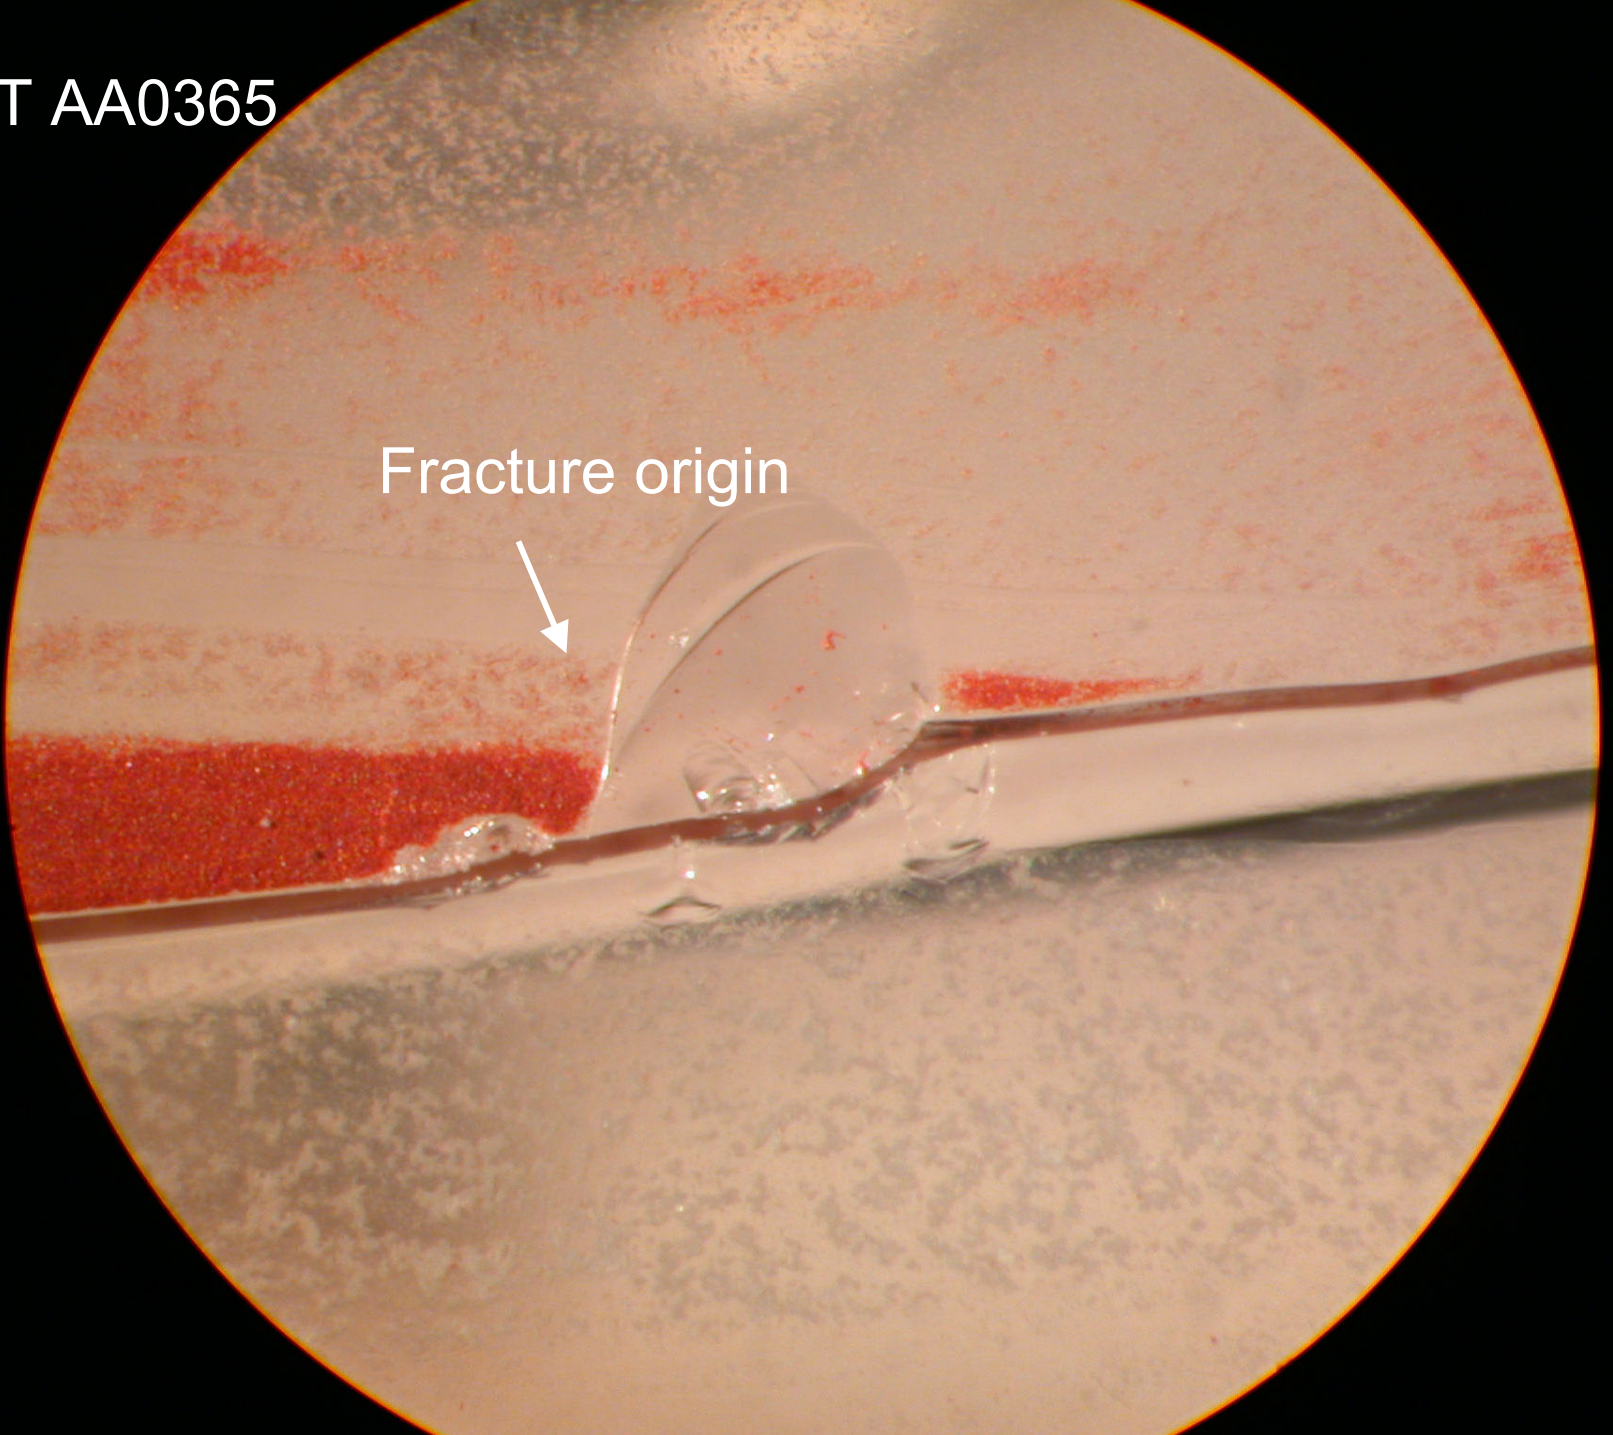
PMT AA0365

Fracture origin

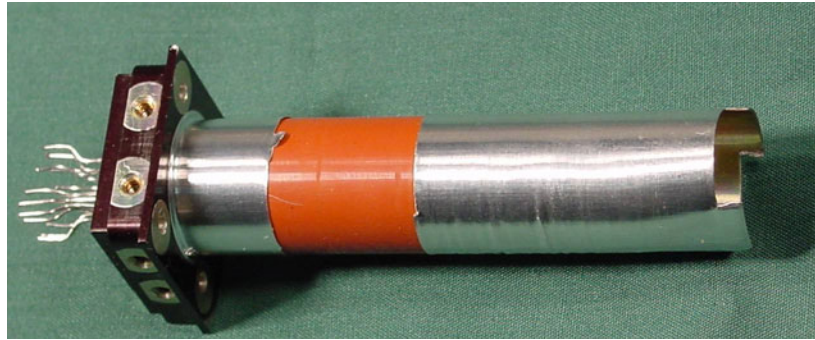
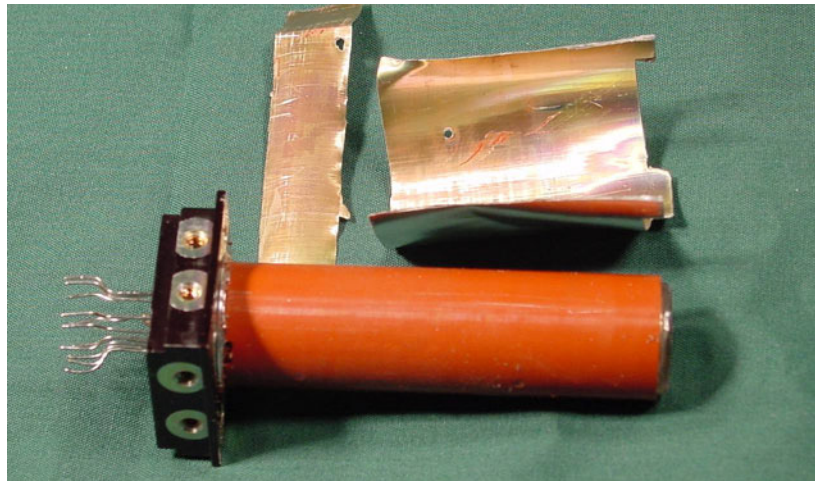
# Removing Housing by Machining

- Successfully machined down to less than 10 mil
- Next, try to cut slots on the housing

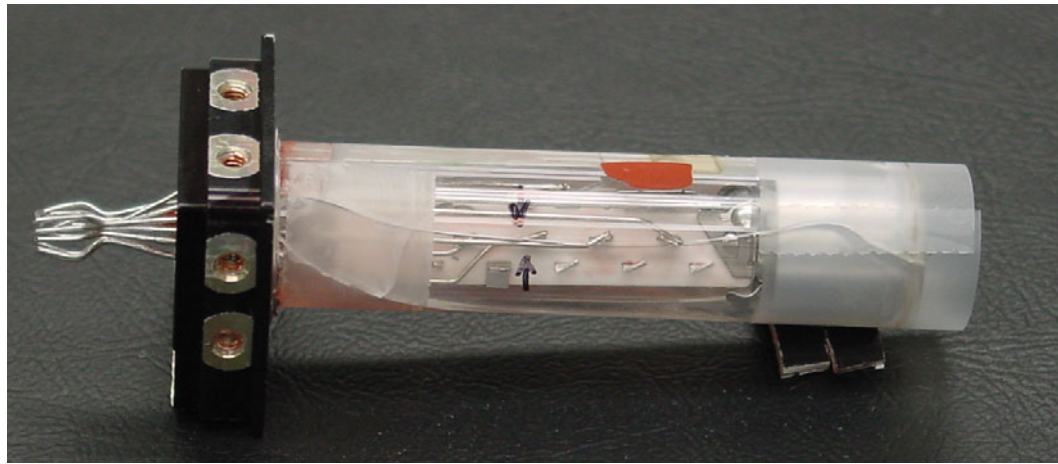
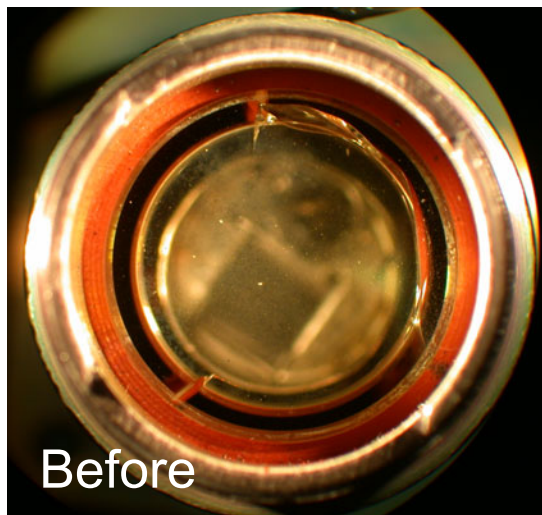
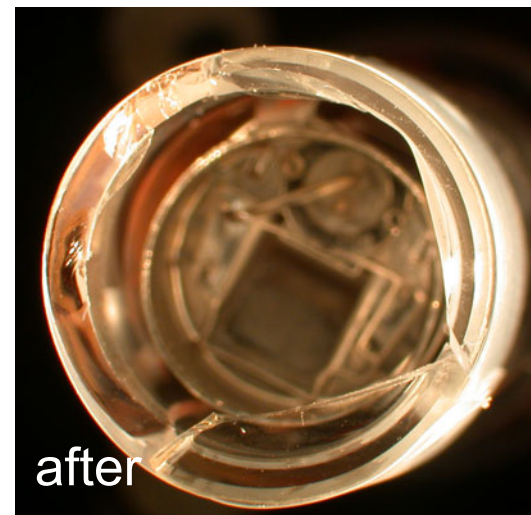
# Removing RTV with Solvent

- RTV dissolved in Dynasolve 210 (Dynaloy) less than 1 hr
- Solvent got into the tube and caused cracks propagate further
