# **GLAST Large Area Telescope: AntiCoincidence Detector (ACD)**

## **PhotoMultiplier Tube Glass Failure**

**NASA Goddard Space Flight Center**

**March, 2004**

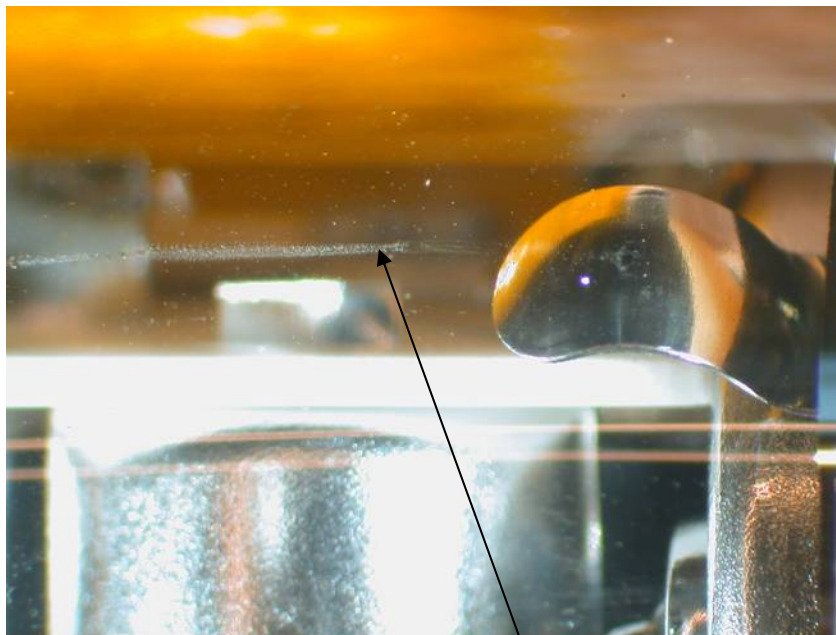
Score line ending  
at dynode mount

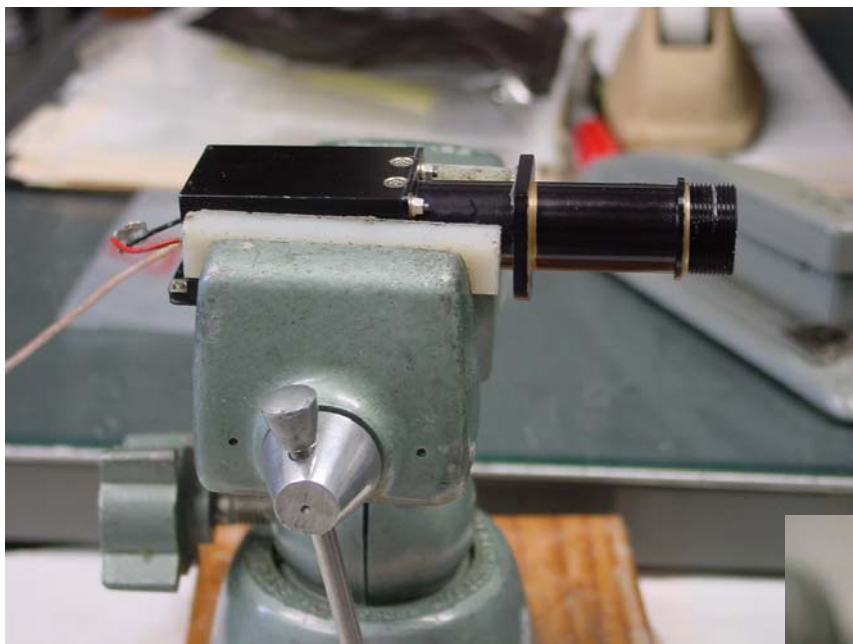
Cut with handsaw and removed the housing piece by piece

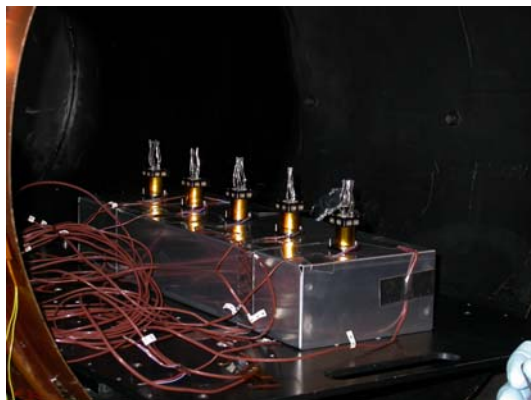
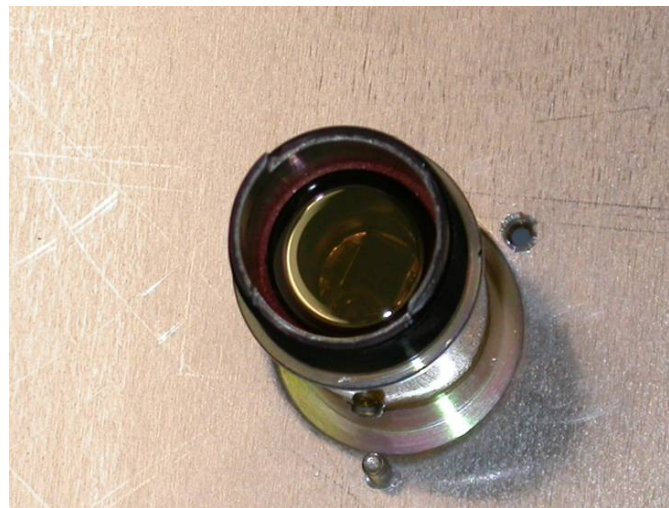
- Pictures of latest qualification units using solution design. These are being verified to qualification levels

- Initial verification results
  - Thermal vac (4 cycle  $+45^{\circ}$  to  $-40^{\circ}\text{C}$ ) was successful!
  - Vibration being done this week.
  - Followed by more severe thermal test (possibly 2 cyc to  $-40^{\circ}\text{C}$  then more cycles to  $-50^{\circ}$ ,  $-60^{\circ}\text{C}$ ) to check for more margin. Just in this morning – successful first cycle to  $-60^{\circ}\text{C}$ .
  - Repeat verification on 10 more NG units, plus bond strength test
  - Also Qualify 5 calibration units, this brings total qualified units to 20

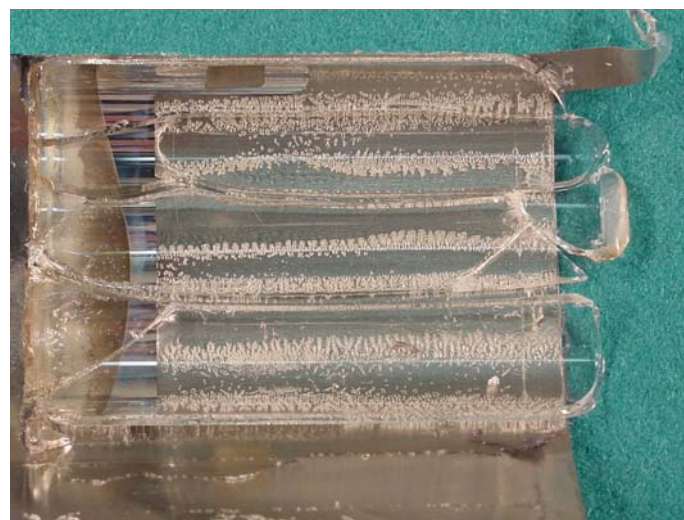
Failed PMT post removal
