# **Failure Analysis of Failed PMTs**

## **Progress report**

7-26-04

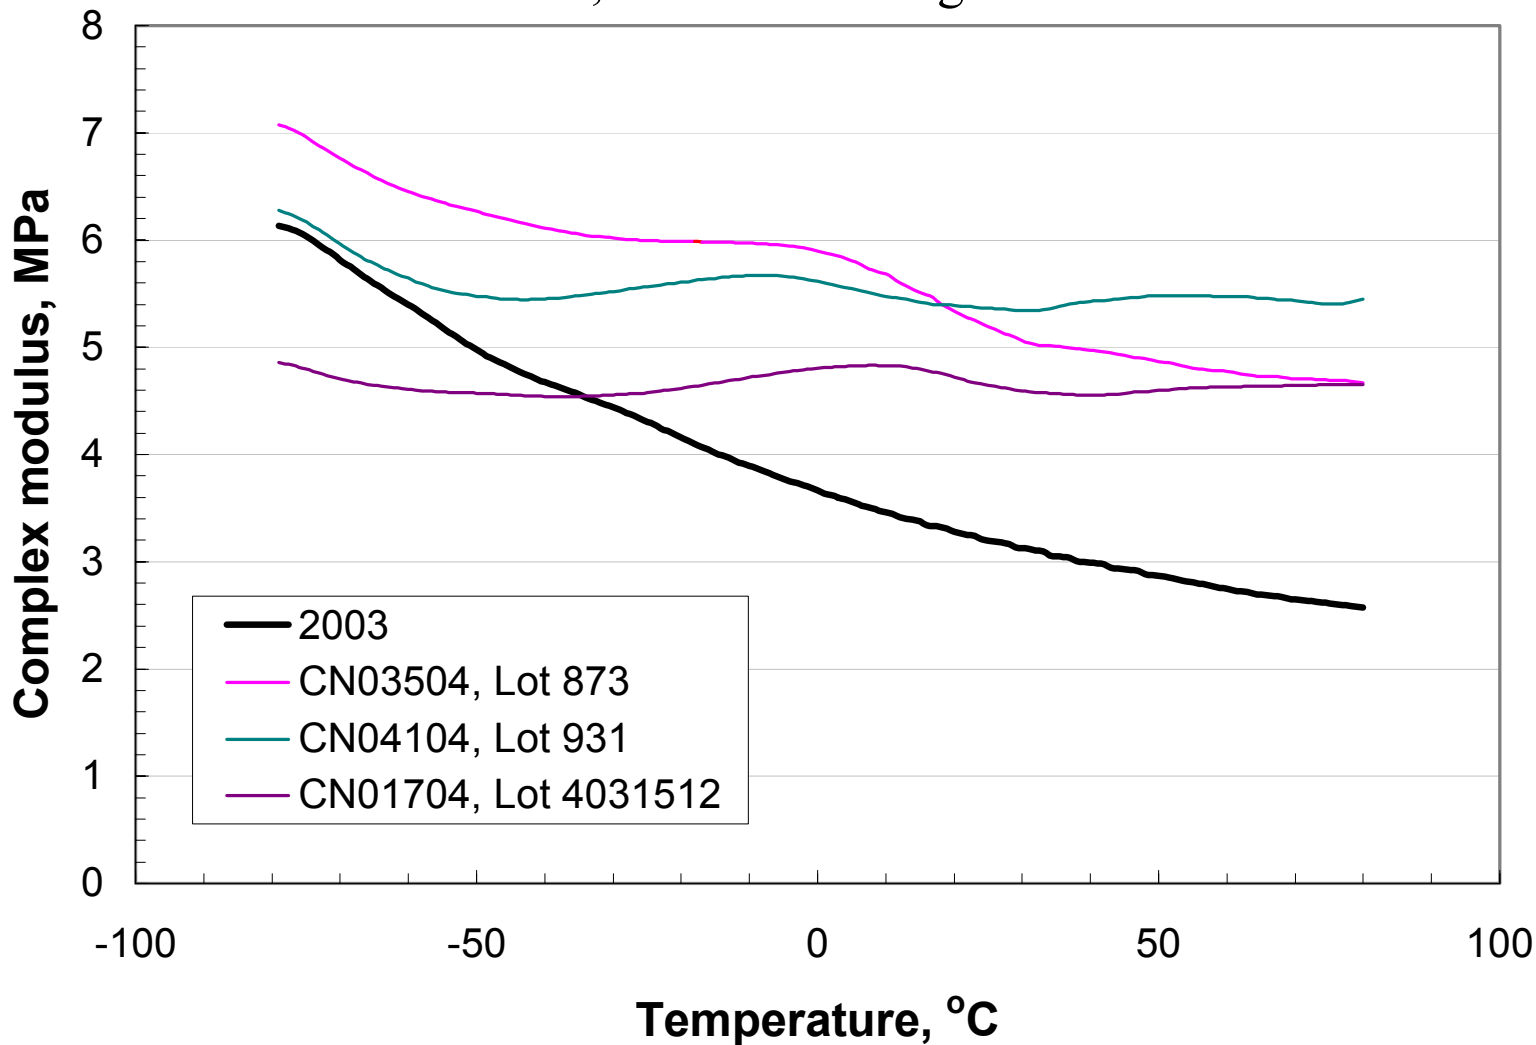
# Modulus of RTV566

Measured with DMA, compression at 1 Hz, 0.05% strain, 2°C/min heating rate

- All 4 PMTs failed from outside flaws in the middle of the tubes
- Aluminum housing successfully removed by machining
- RTV can be dissolved by solvent, but more crack propagation observed
- Modulus of RTV varies between lots, but not significantly. Strain-dependent.
- Curing shrinkage about 0.2% (volume), mostly in the first 24 hrs.
- Poisson's ratio of RTV566 doesn't change with temperature from -60°C to +40°C
